# SUCCESSFUL RELOCATION OF AN OSPREY NEST AFTER EGG-LAYING

**Blanche E. Town (corresponding author)**

**Clede R. Spooner**

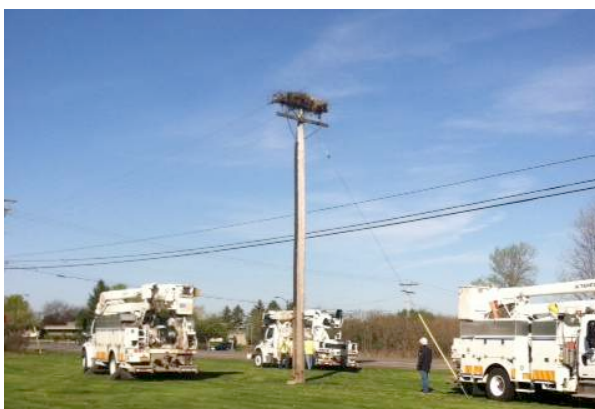
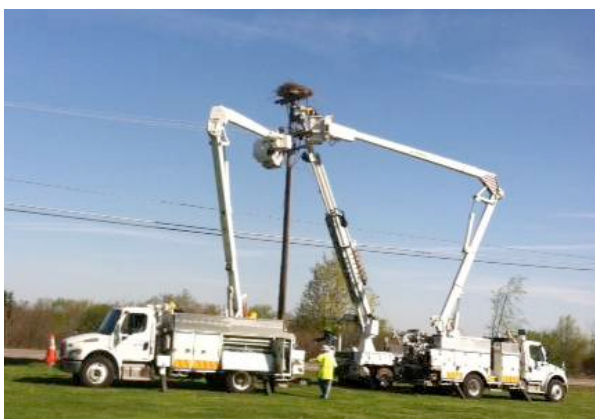
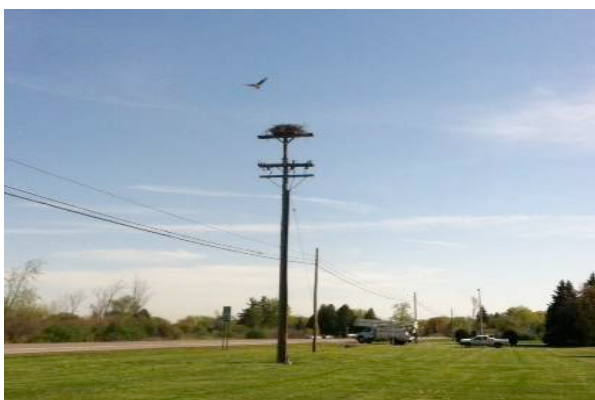
Figure 2. (a) Established nest (top); (b) Raising nest (middle); (c) Osprey return (bottom).

On 6 May DEC wildlife staff joined NG crews on site. One Osprey was observed incubating and another flew in to the nest as NG cut power to the pole and two bucket trucks moved into place on either side of it (Fig. 2a). As the buckets moved closer, the adults left the nest. Linemen in the buckets lifted the nest from the pole using "hot sticks". The nest was lashed securely to the sticks and then lifted off from the top of the pole and set onto a platform. The platform had been previously bolted onto a fiberglass pole extension. The pole extension

and platform were supported by a third truck. This truck then raised the adaptive structure above the power pole (Fig. 2b) and guided by the linemen, eased it onto the top of the pole where it was bolted into place.

From the time the trucks set up on site until the time they departed, approximately 50 min elapsed. The adult Ospreys remained in the area, alternately circling or perching in trees near the nest. Within five minutes of the trucks moving away from the pole, an adult was back on the nest (Fig. 2c). The linemen reported that the eggs were covered with mossy vegetation and only partially visible during the move. It was a cool, windy day, but sunny, with temperatures steady around 12.8 °C.
