# AVIAN WINDOW STRIKE MORTALITY AT AN URBAN OFFICE BUILDING

*Abstract*—During 2005, NYC Audubon's Project Safe Flight program led a citizen science project to study avian collisions at one of Manhattan's worst bird-collision sites. Over the course of that year, 251 birds were documented to have collided with the six-story office building, 90% of which were found dead. Most of these collisions occurred during daytime hours, and almost all involved passage-migrants during spring and fall migration. Higher strike rates were documented along the glass surfaces that reflected densely vegetated areas than along surfaces opposite less-vegetated areas. Because structures with similar glass and vegetation characteristics are numerous and widely distributed, it is likely that such structures collectively represent a threat to migratory bird populations, especially given that several species involved in collisions are also on the US Fish and Wildlife Service's list of Species of Management Concern. Possible solutions to this problem include netting and glass etching which can eliminate the reflectivity of windows. Other solutions include the development of a new type of glass that is transpa

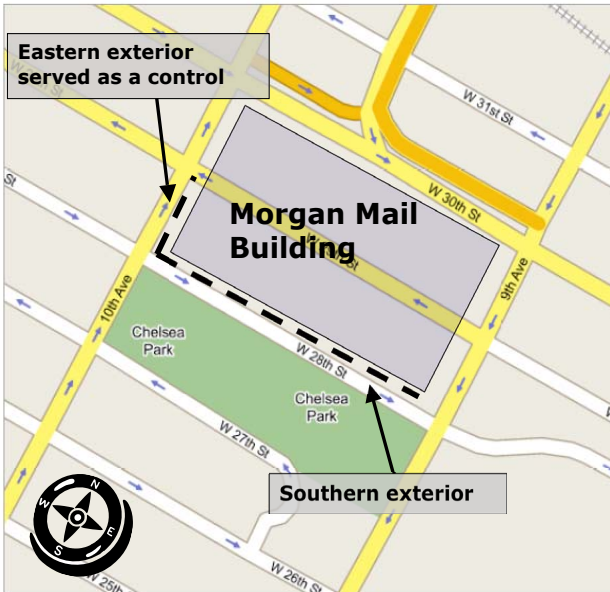
Figure 2. The Morgan Processing and Distribution Center, Manhattan, New York.

The Morgan Mail building is a six-story office building where relatively high numbers of bird collisions have been recorded since 2002. The building is located in Manhattan between 28th and 29th Streets and between 9th and 10th Avenues (40° 45' 02" N, 73° 00' 01" W). During 2005, when the present study was conducted, the building's exterior was made up of windowless concrete walls for the first two stories and 440 large, reflective glass panels (each 2.3 m by 1.3 m) covering approximately 75% of the remaining four stories (the "windows" actually mask an interior-concrete wall). All exterior walls ran straight from the base of the building to the rooftop, with no major outcrops or ledges that could prevent colliding birds from falling to the street level. The southern perimeter of this building (247 m) faced a row of short street trees that did not reach the building's window line. Opposite the building, on the south side of the street, was a row of large street trees (mostly London Plane trees, *Platanus x acerifolia*), many of which were over 20 m tall and reached to the top of the six-story structure. Beyond this row of trees extended a rectangular 1.42-hectare urban park (Chelsea Park) with more tall trees (again, mostly London Plane trees), some of which were also reflected in the building windows. The vegetation at this park was not uniformly distributed; whereas the eastern portion of the park included many large trees, the western portion of the park – amounting to slightly less than half of the entire park – was much less vegetated, partly due to the fact that most of the space was taken up by a large ball-field covered with artificial turf. The building's position in relation to its surroundings is shown in Figure 2.
